# NEWSLETTER

PUBLIC OVERVIEW OF HESS PROJECT

Project no:  
101112380 - HESS - RFCS - 2022

## Selection of the optimal sealing material for the mine shaft lining serving as a low-pressure CO<sub>2</sub> tank in HESS

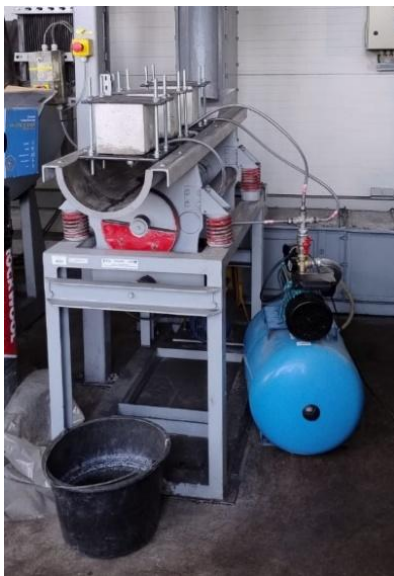
*Test stand for testing liquid permeability through concrete (a), test stand diagram (b), 1. Bolt, 2. Steel plate, 3. Flat gasket, 4. Concrete sample, 5. Pressure flat bar, GW1/2" - pressurized water connection.*

As part of the HESS project, water and brine permeability tests were carried out under pressure (6 bar) on structural concretes C20/25 and C35/45, both uncoated and protected with Sikagard® WallCoat T and M 790 coatings, in accordance with PN-EN 12390-8.

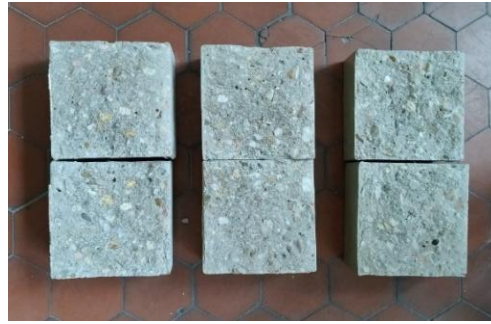
*Samples of concrete class C35/45 (a) and concrete coated with Sikagard® M790 (b) after completion of permeability tests using brine.*

The results showed clear differences between the concrete grades: C35/45 exhibited stable and low penetration depths for both media, confirming its dense and homogeneous microstructure, while C20/25 showed higher variability and greater sensitivity to the type of liquid. Concrete samples coated with Sikagard® M 790 and Sikagard® WallCoat T demonstrated complete resistance to liquid penetration, both after 72 hours and after two months of testing. The coatings also improved the mechanical performance of the samples, increasing their fracture resistance. Both systems performed comparably within the test duration. Overall, the results confirm that properly coated concrete is a suitable construction material for PSH tanks, providing very low liquid permeability and high durability under operational conditions.

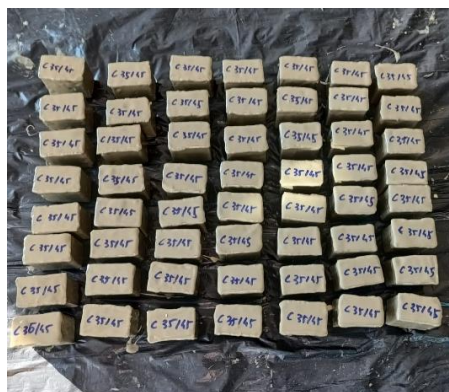
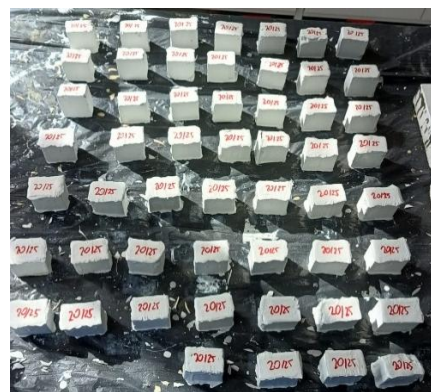
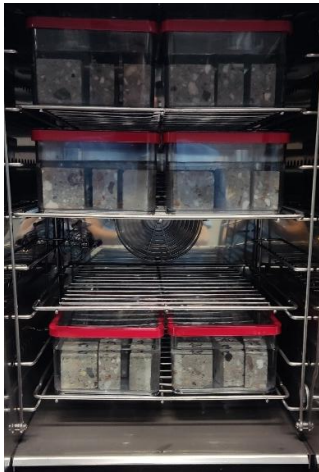
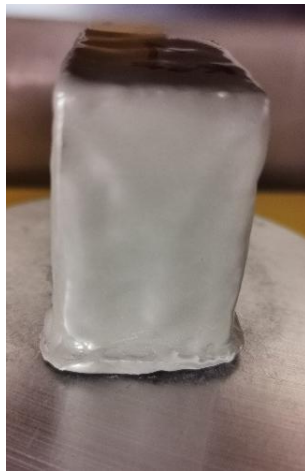
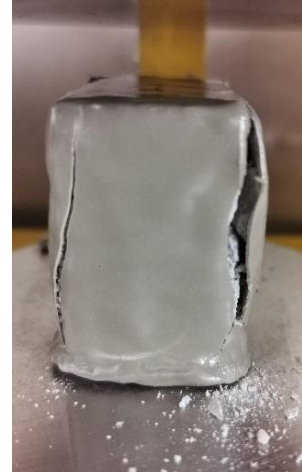
*Concretes covered with coating Sikagard® M 790 (a), Sikagard® WallCoat T (b), corrosion immersion chamber test (c), compressive strength test for coated samples before compression test (d), after compressive destruction (e).*

For concretes coated with both Sikagard® coatings, no sample mass loss was observed during the test period of up to 180 days of exposure to corrosive factors. The compressive strength of the tested concretes treated with both coatings was within the strength classes of both types of concrete. Thanks to the coatings, the underlying concrete remained largely unaffected, preserving its compact and stable structure. Most of the coated samples showed smooth, uniform surfaces with no signs of flaking. Only the Sikagard® WallCoat T coating exhibited noticeable changes when exposed to a 5% acid solution, where surface blistering was observed - indicating reduced resistance under strongly acidic conditions. In case of the Sikagard® M 790, no changes in the coating structure were observed excluding a colour change (from grey to rotten green) upon exposure to acid. Changes were observed on both types of coatings after 28 days of exposure.

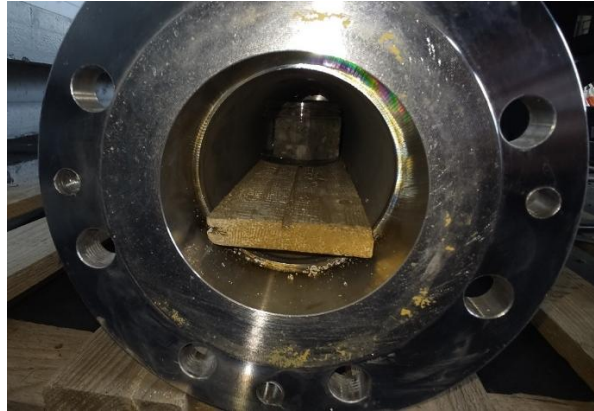
*System for testing corrosion resistance under 6-bar CO<sub>2</sub> pressure.*

Corrosion tests were also carried out under 6-bar CO<sub>2</sub> pressure - conditions representative of a CGES storage tank. The samples were exposed to water, 5% chloride, magnesium, and sulphate solutions, as well as brine, reflecting real mine environments. Testing lasted up to 60 days, allowing assessment of coating performance under combined chemical and CO<sub>2</sub>-rich conditions.

In CO<sub>2</sub>-saturated corrosion tests, both coatings remained stable with no signs of degradation. Sikagard® WallCoat T showed only minor surface changes related to the mildly acidic conditions created during CO<sub>2</sub> dissolution, but these did not affect the concrete's mechanical strength. Overall, both Sikagard® WallCoat T and Sikagard® M 790 provided effective protection in chloride-, sulphate- and magnesium-rich environments, high-salinity mine waters, even acidic conditions, and under CO<sub>2</sub> pressure, with M 790 showing the highest resistance. Coated samples outperformed uncoated concrete, particularly in highly aggressive environments.
